IMAGE Failure Review Board Final Report

Executive Summary

September 19, 2006

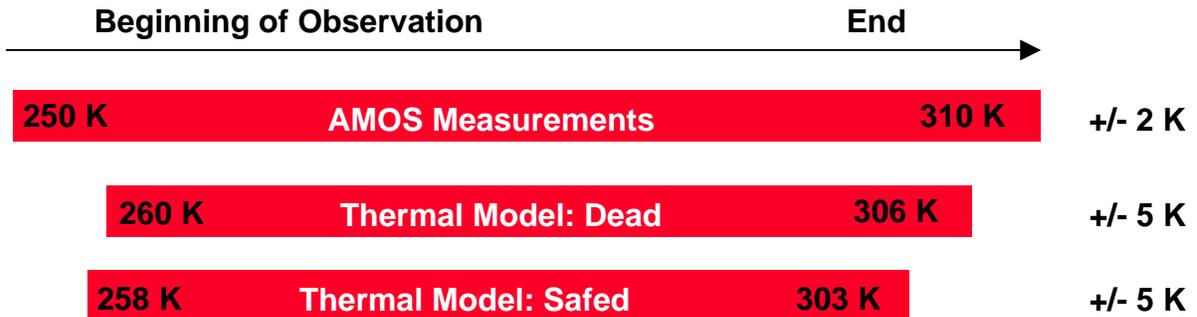
Figure 4-1: Summary of AMOS and thermal model temperature comparisons.

Thus, the analysis was conducted by comparing AMOS measured bulk average body temperatures to corresponding temperatures predicted by thermal modeling (conducted by Goddard's Thermal Branch). The thermal modeling included estimated degradations of thermal coatings and solar array efficiency (at 6 years, IMAGE's current age) as well as the generation of geometric math models that included environmental heat fluxes and orbital profiles. The temperature predictions also accounted for the changing view profile and sunlight illumination occurring during the AMOS observation, since this is a large determinant on what temperature is 'seen' and measured. For example, mostly the end panel of the IMAGE spacecraft (largely in shadow) was visible at the beginning of the AMOS observation, which changed to a mostly illuminated side panel visibility toward the end of the observation⁸. The results are shown in

Figure 4-1, which shows the comparison of beginning and end of observation temperatures for the AMOS measurements vs. the two modeling cases discussed above. As can be readily seen, although the thermal models have good agreement with the AMOS measurements, the temperature difference between the model cases is smaller than the error in each. This is due largely to the fact that a large percentage of all 10 sides of the IMAGE spacecraft are covered with solar arrays that dominate the average temperature observed and predicted⁹. Additionally, the solar array temperature is largely invariant over the relatively small range of loading conditions between nominal operations, safemode, and a ‘dead’ state where no power is drawn from the array.¹⁰ Thus, the comparison of temperature measurements and predictions is inconclusive in determining the safed vs. dead state of IMAGE.

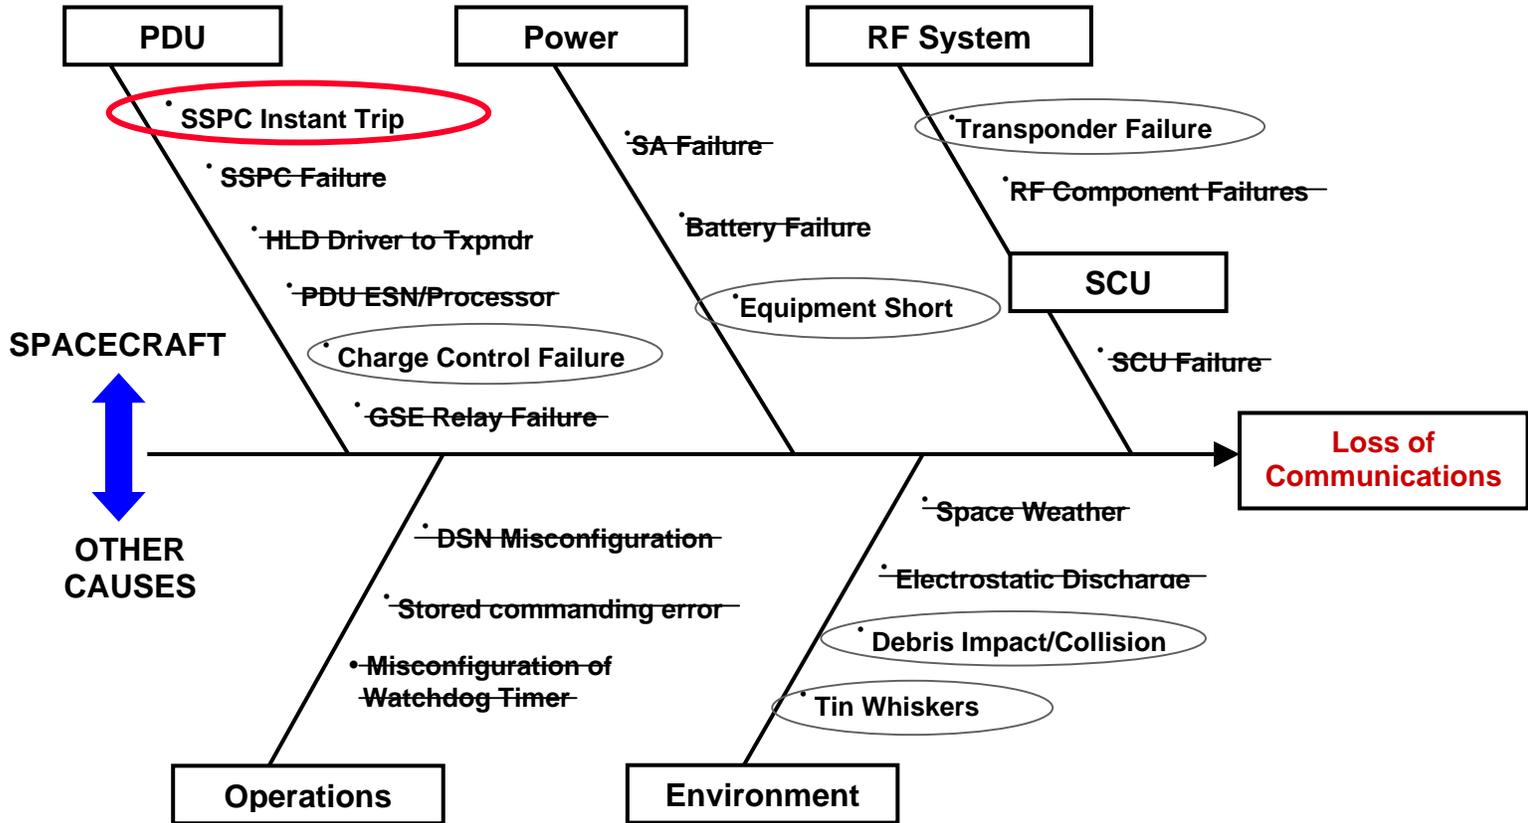
Figure 4-2: Fishbone fault analysis summary.

The result of the fault analysis was that the most likely root cause of the loss of communication event was a loss of communication capability due to the Transponder SSPC inadvertently opening (an instant trip event). This would put the Transponder into an unpowered state unable

to provide any communications capability to the spacecraft. However, several other possible causes, although considered unlikely, cannot be completely ruled out. They are; 1) Charge control system failure, 2) Massive short in the PDU or Transponder, 3) Transponder Transmitter failure, 4) Micrometeoroid or orbital debris (MM/OD) impact, and 4) Tin whisker growth resulting in massive short circuit.

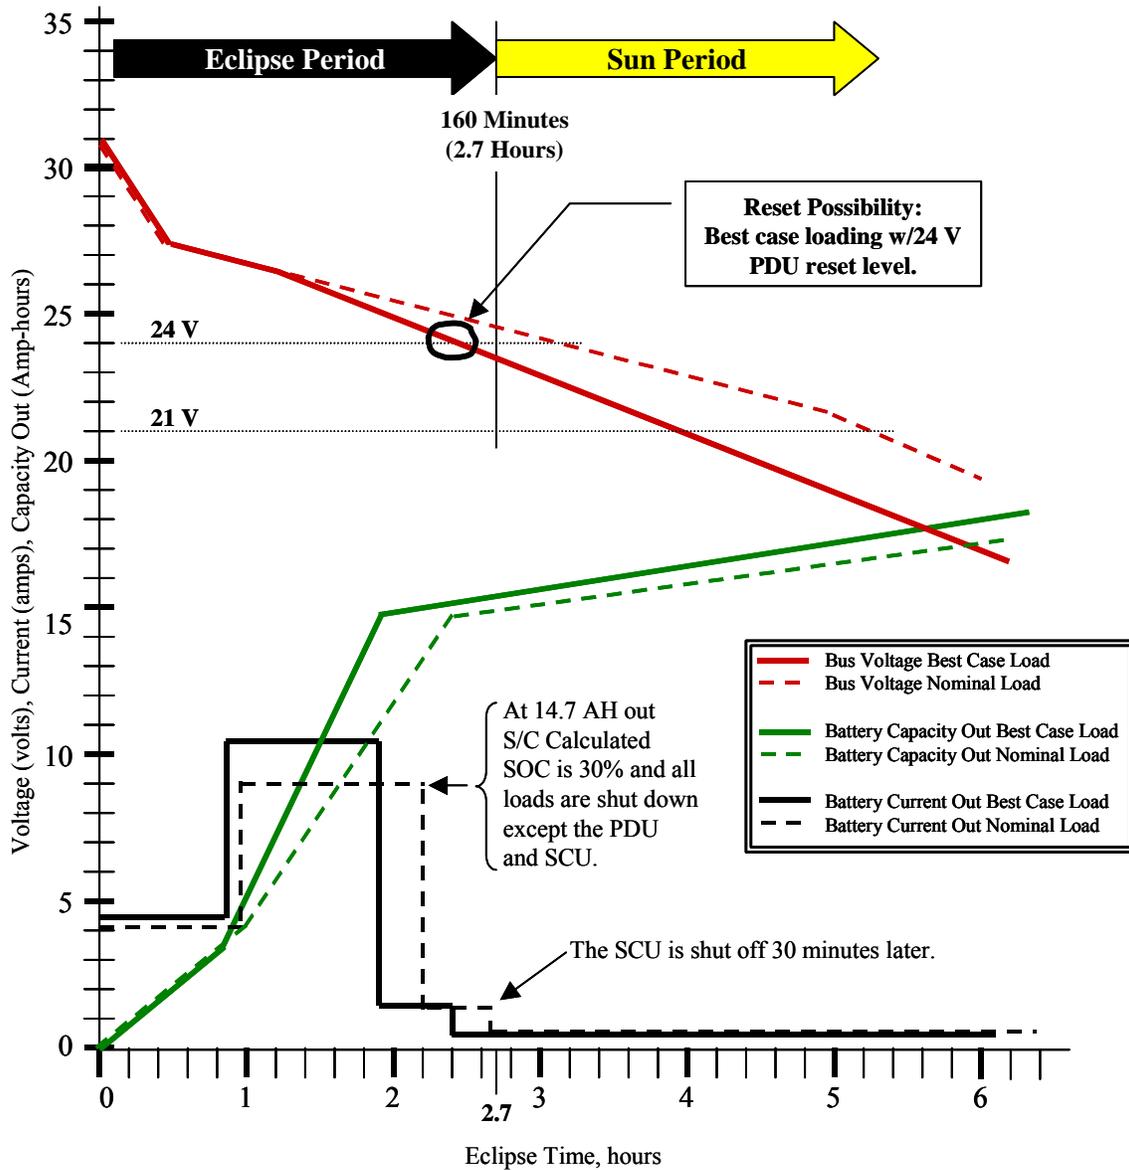
Figure 5-1: Eclipse Discharge Summary for Nominal and Best Case Load Estimates.¹⁹

The adjusted capacity curve is then scaled up in voltage by a factor 22 since the test data was taken for a single cell while the flight battery is 22 cells in series. The capacity curve time scale is then converted to equivalent orbit time for the October 2007 eclipse scenario by using the load profile curve discussed above (by calculating the time to discharge to the indicated capacity under the eclipse load current profile). The final result is an idealized discharge curve scaled for on-orbit load current profile and battery age. See Figure 5-1 for the discharge curves for nominal and best case bus loading, respectively.

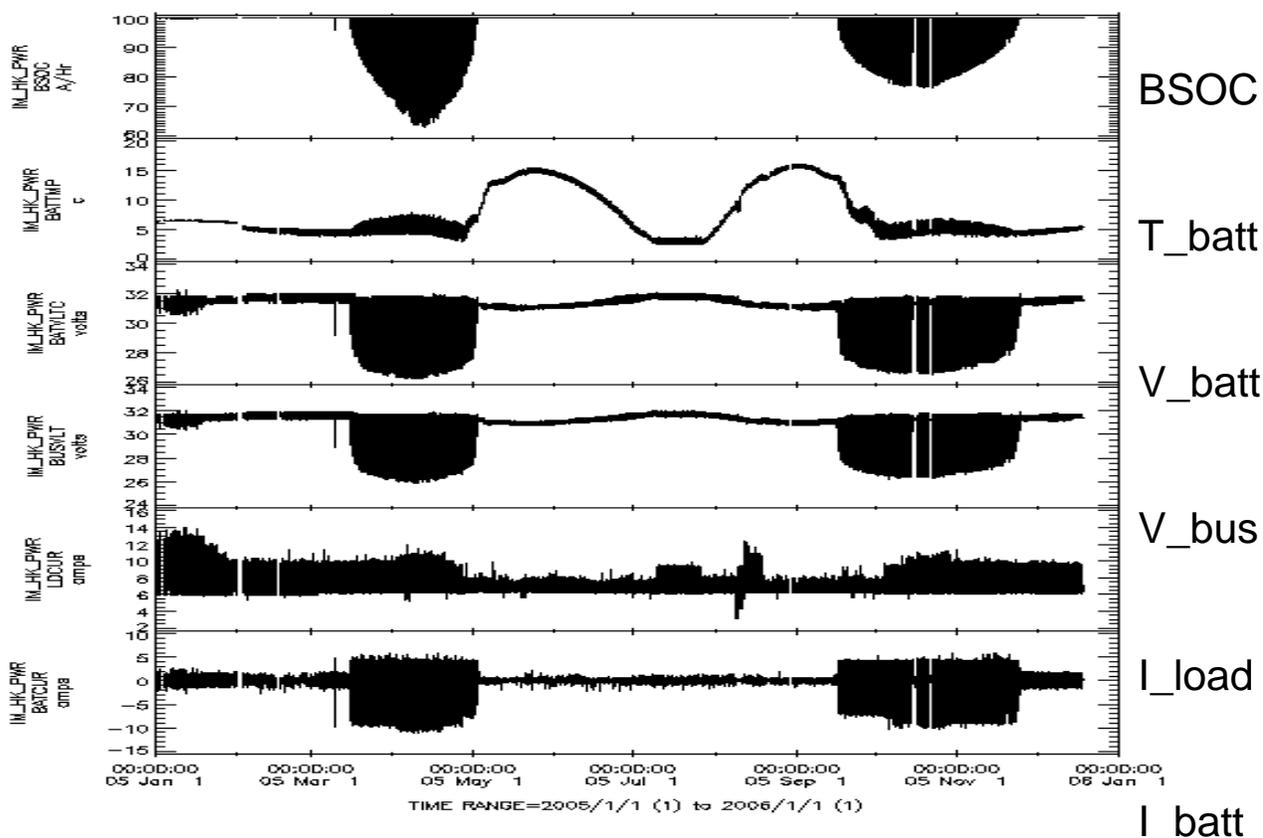
Figure A-1. Battery/bus temperature and voltage trends under typical loading.

Conclusion: IMAGE has no history of battery anomalies (see Figure A-1 for typical trending data). All available telemetry showed healthy batteries and no indication of cell shorting or other battery degradation. The probability of multiple battery cells shorting over a short period (~8.5 hours²³) is highly improbable. Battery shorting is not a likely cause for the failed communication capability.

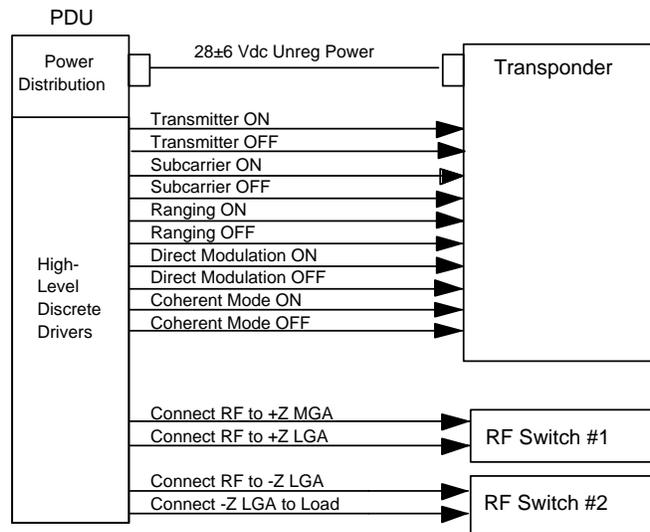
Figure A-3. High Level Discret control of Transponder.

Analysis: The Transmitter ON/OFF state is controlled by an internal Transmitter latching relay that is controlled by High Level Discret (HLD) pulses. A separate HLD circuit exist for the ON and OFF command function (see Figure A-3).

The most likely failure mode of the Transmitter HLD concerns three transistors controlling the Transmitter ON/OFF state, any of which if shorted allows the controlling relay coil to be continuously energized.

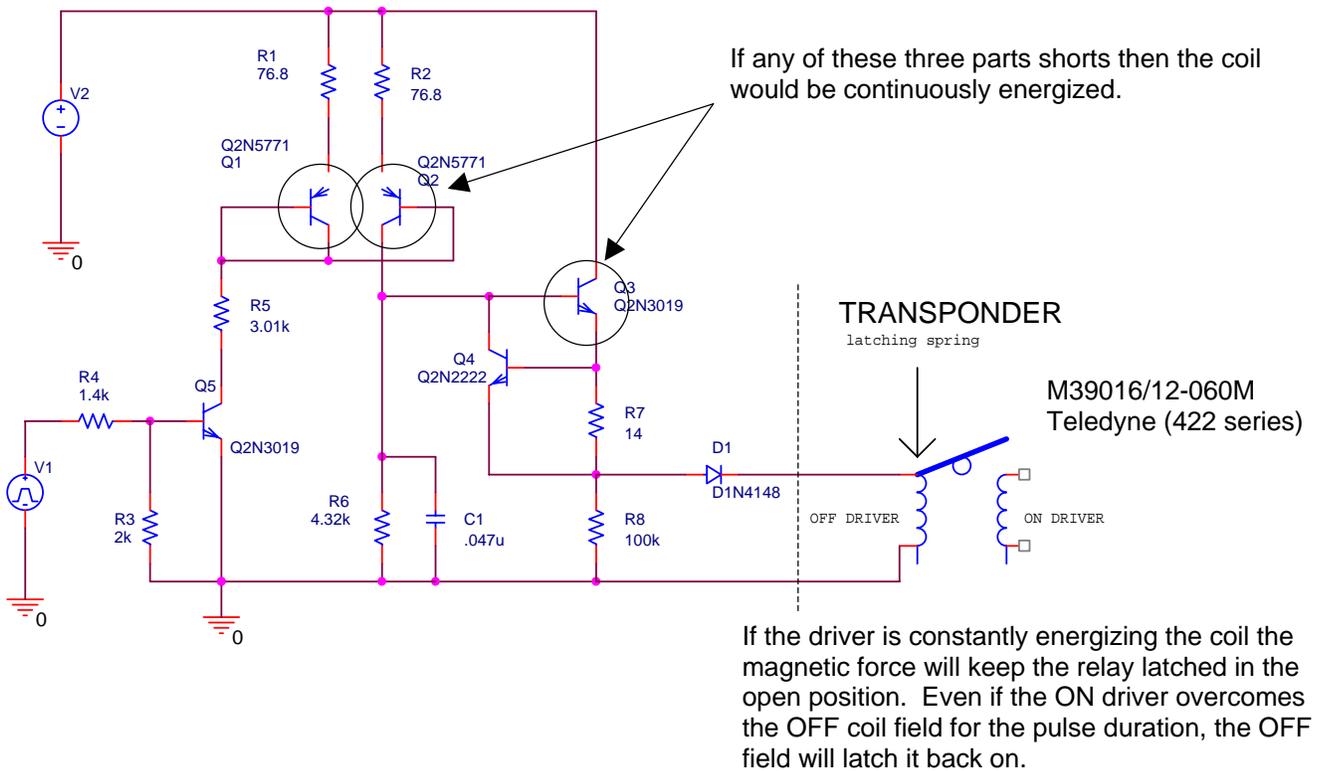
Figure A-4. Transponder HLD circuit description.

If the driver is constantly energizing the coil the magnetic force will keep the relay latched in the open (transmitter off) position. Even if the ON driver command subsequently overcomes the OFF coil field for the pulse duration, circuit analysis indicates that the OFF field will latch it back on. See Figure A-4 for HLD circuit description.

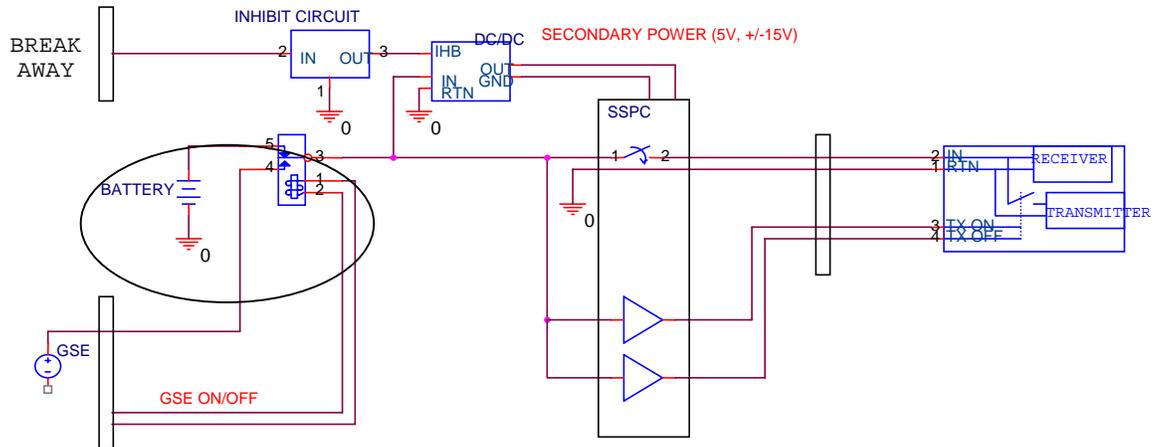
Figure A-5. GSE circuit configuration.

Analysis: The spacecraft has a relay that was used in I&T to control the application of either the spacecraft’s battery or GSE supplied power to the spacecraft bus. The relay is controlled through the GSE interface. There is no on-board circuit capability to change the GSE relay state (see Figure A-5).

If the relay were to fail in orbit by switching to the GSE source position, battery power to the bus is interrupted. However, the power system design is such that in a full sunlit orbit the bus is clamped to 35V and no interruption of power would occur until eclipse. The original loss of communications event occurred with the IMAGE spacecraft in a full-sunlight orbit. If the relay were in the GSE position since launch IMAGE would have experienced power loss in previous eclipse seasons – which has not been observed.

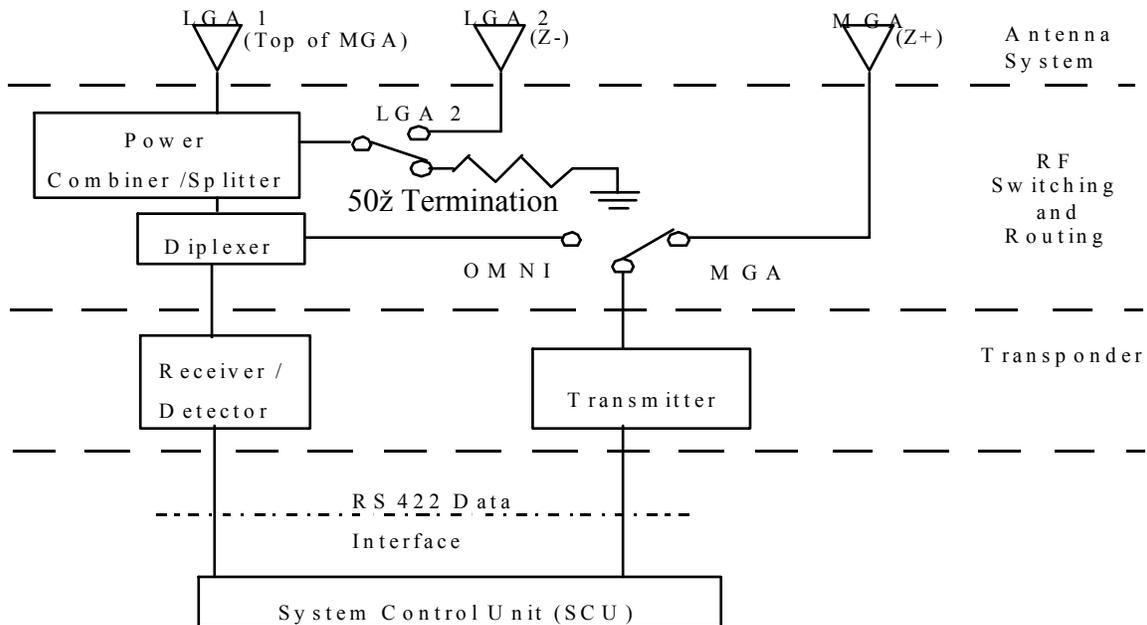
Figure A-6. RF system functional block diagram.

Analysis: Passive components of the RF system consist of a power splitter, diplexer, antennas, two latching mechanical relays, and coaxial cable (see Figure A-6). Active components are the Transponder itself.

Operational experience with similar passive components shows that failures are extremely rare and are typically not catastrophic when operated under a steady state condition. IMAGE RF system operation, from shortly after launch, was a continuous broadcast of 44 Kbps telemetry from the Medium Gain Antenna (MGA) antenna. Commands were received from the coaxially aligned +Z omni antenna. The mechanical RF relays were left in the configuration to allow broadcast mode. Broadcast mode was only interrupted three times due to SCU reboots that command the RF relays into a dual omni mode. Thus, the total number of cycles to the mechanical relays was well below the MTBF value, which is typically in the thousand of cycles
