IMAGE

Failure Review Board Final Presentation

April 21, 2006

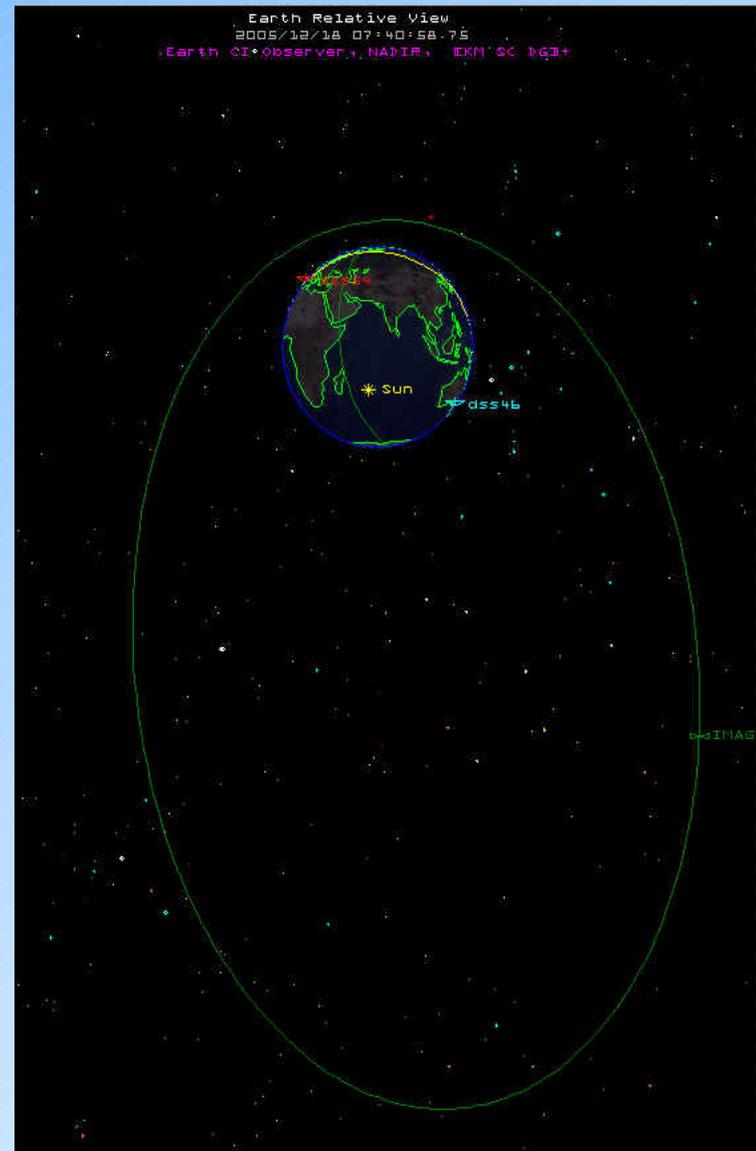
GMT	Activity
2005/352 0714	All instruments to full science
2005/352 0740	End of Good DSN pass @DS-34 (see diagram)
2005/352 0755	Configure RF for low-rate via stored command
2005/352 1125	IMAGE at apogee
2005/352 1515	Configure RF to high-rate via stored command
2005/352 1620	No IMAGE RF signal @DS-34

~ 8.5 hours elapsed between the last successful and the first failed contacts.

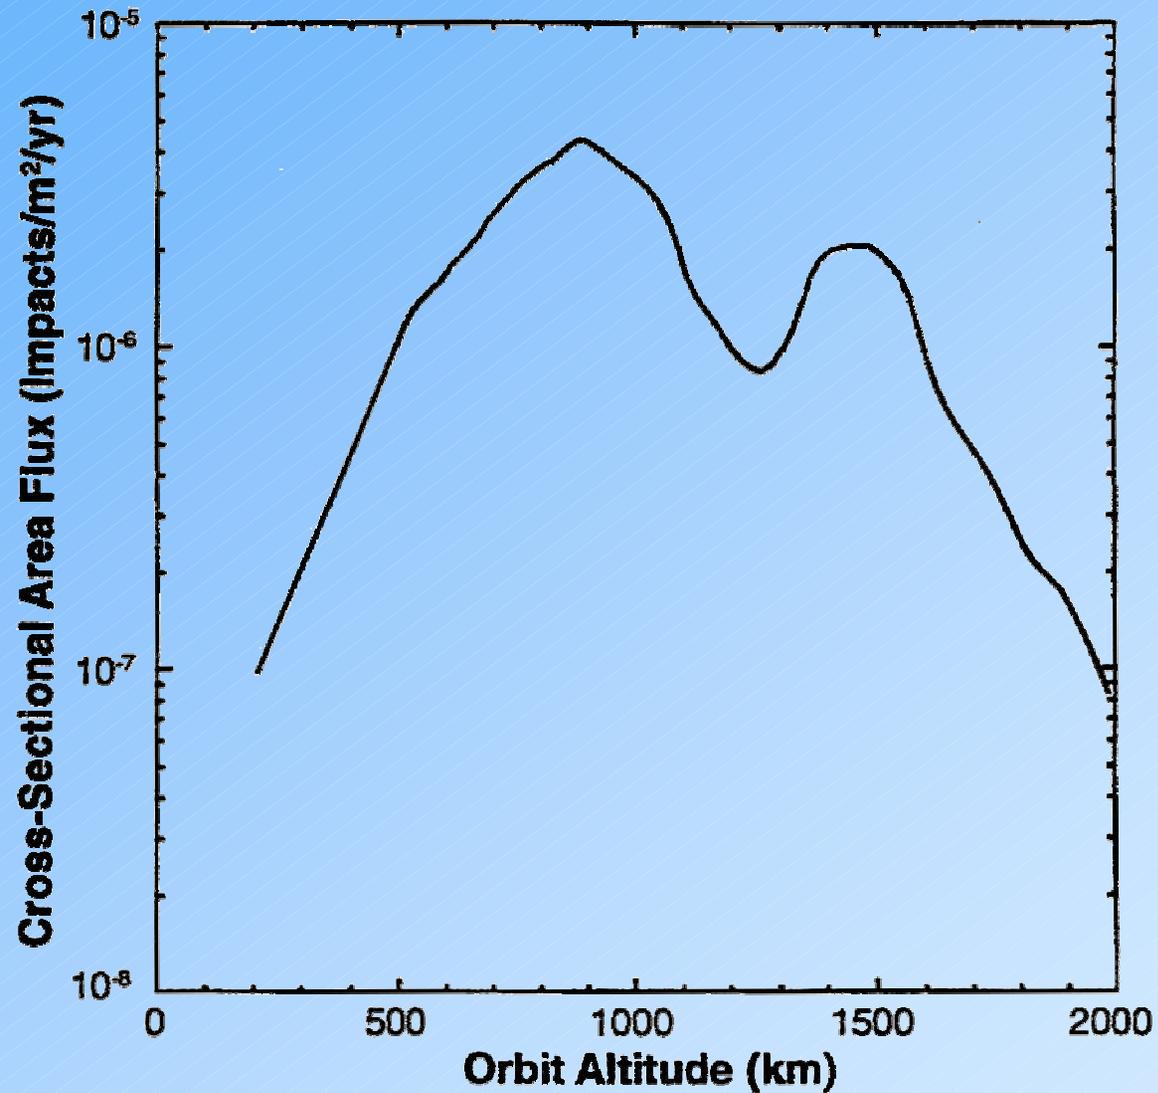
- ❑ **Cause:** Catastrophic mechanical damage by orbital debris large object (>10cm) impact
- ❑ **Analysis:** The IMAGE orbit approaches significant orbital debris flux only briefly at perigee (1000-2000km in a 1000 x 44,000km orbit), and the flux is negligible for the majority of the orbit. IMAGE did, however, pass through perigee during the seven hours following the last successful contact. USSTRATCOM Collision assessment reports no debris within 50km of IMAGE, and updated TLEs made with active radar match JPLs, and suggest no impact-induced Delta-V.

Conclusion: Impact with large debris should cause observable changes in the spacecraft orbit. No such changes occurred. In addition, no tracked large objects were detected within 50km of the spacecraft at the time of the anomaly, either as a cause or a result of collision. The IMAGE downlink anomaly could not have been a result of impact with a piece of tracked orbital debris.

- ❑ **Supporting Details:** A graph showing the altitude distribution of orbital debris is attached.

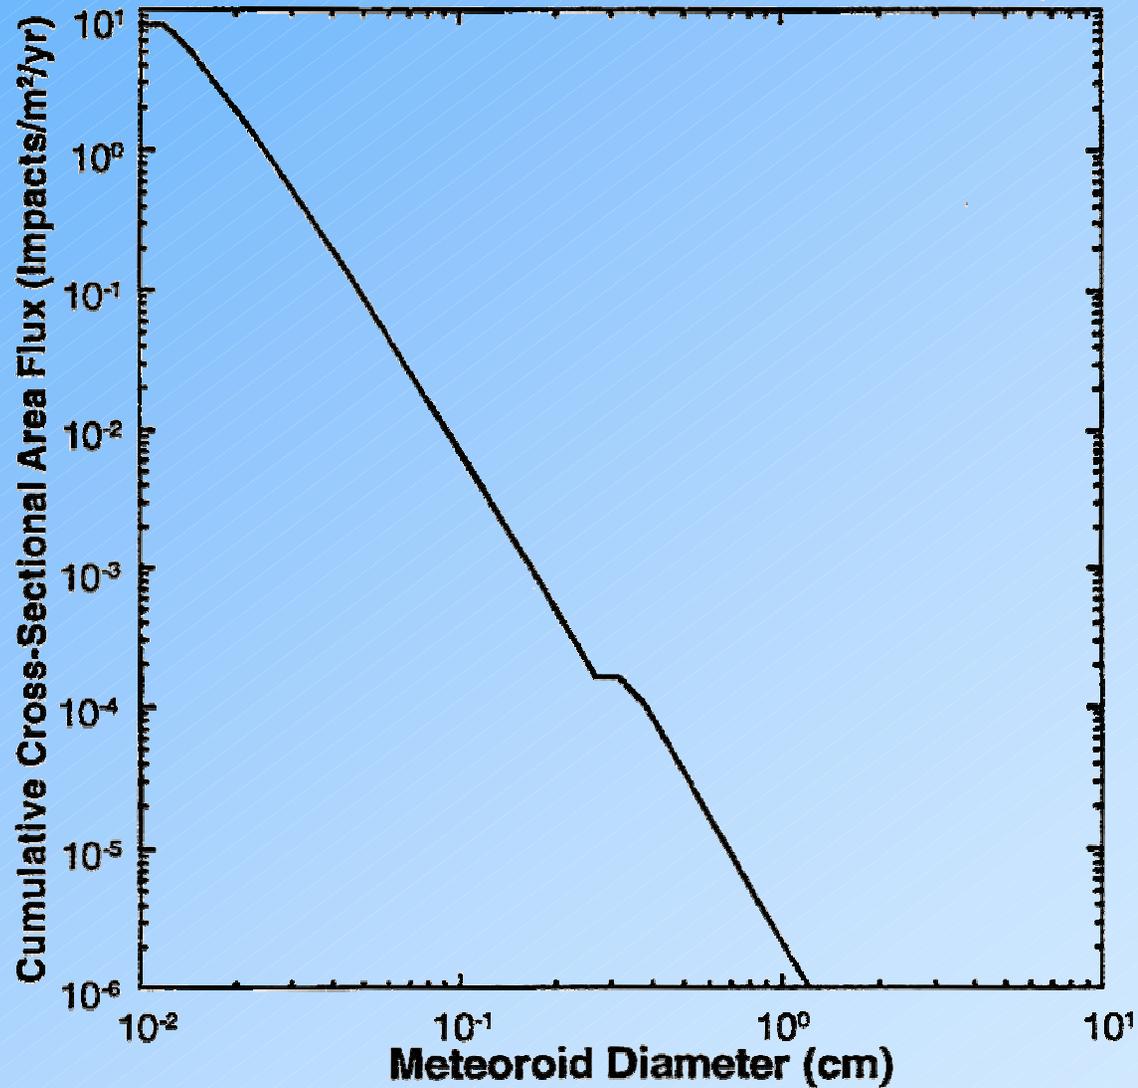
- ❑ **Cause:** Micrometeoroid or orbital debris (MM/OD) impact ($<10\text{cm}$ diameter)
- ❑ **Analysis:** Man-made debris is concentrated at 500 to 1500 kilometers altitude, a region which the IMAGE orbit crosses only briefly. Small micrometeoroid flux is comparable, but distributed evenly throughout the orbit. A random small object at high velocity (as high as 70km/sec for micrometeoroids) could pass through the spacecraft wall and penetrate the transponder or PDU, causing box failure.
- ❑ **Conclusion:** The likelihood of an MM/OD impact on the transponder is extremely low, due to the geometry involved and the relatively low particle flux, but it can not be ruled out. MM/OD damage is a possible cause for the IMAGE downlink anomaly, but it is very unlikely.
- ❑ **Supporting Details:** A graph showing the size distribution of micrometeoroids is attached.

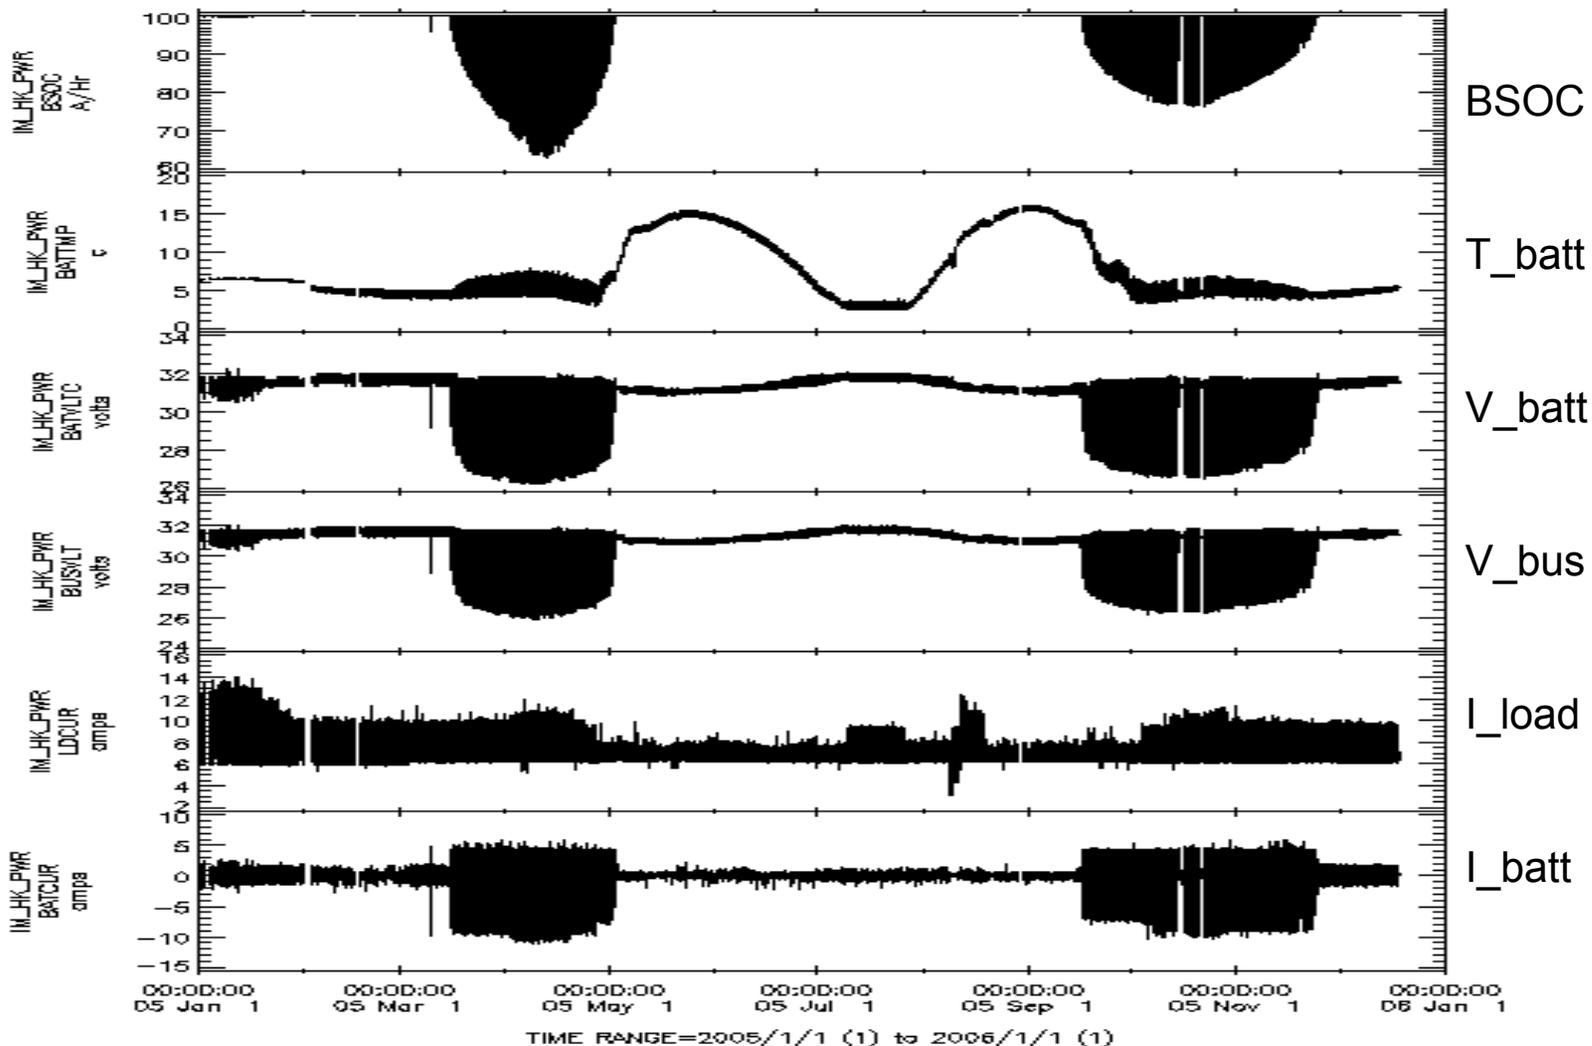
Battery Failure Trends Under Typical Load

- ❑ **Cause:** Battery internal open.
- ❑ **Analysis:**
 - Any single cell suffering an open circuit type failure would halt the ability of the battery to generate current and service the load.

- **Loss of bus voltage would occur during eclipse periods.**
- ❑ **Conclusion:** The loss of communications event occurred during a period of continuous sunlight (no eclipse). If a battery open cell failure had occurred, the Transponder would have continued functioning with no loss of communications occurring. A battery open cell failure cannot be a cause of the failed communications.

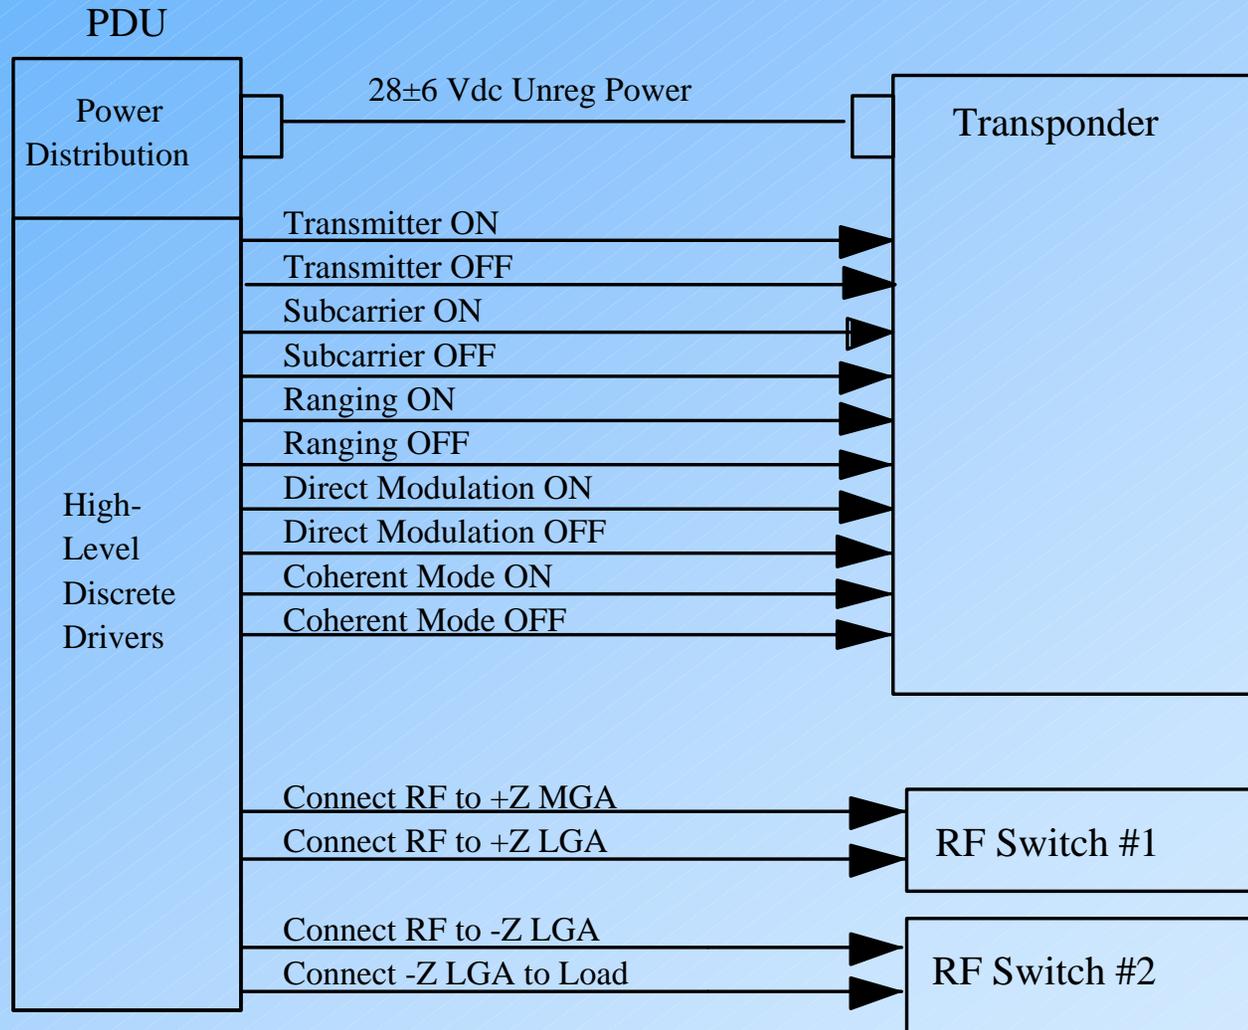
- ❑ **Cause:** High Level Discrete (HLD) Driver for transmitter ON/OFF fails.
- ❑ **Analysis:** The most likely failure mode of the transmitter HLD concerns three transistors controlling the transmitter on/off state, any of which if shorted allows the controlling relay coil to be continuously energized.

- ❑ **Conclusion:** Based on the use of the Transmitter ON HLD driver during the mission it is highly unlikely for a failure in this circuit.
- ❑ **Supporting Details:** HLD schematic

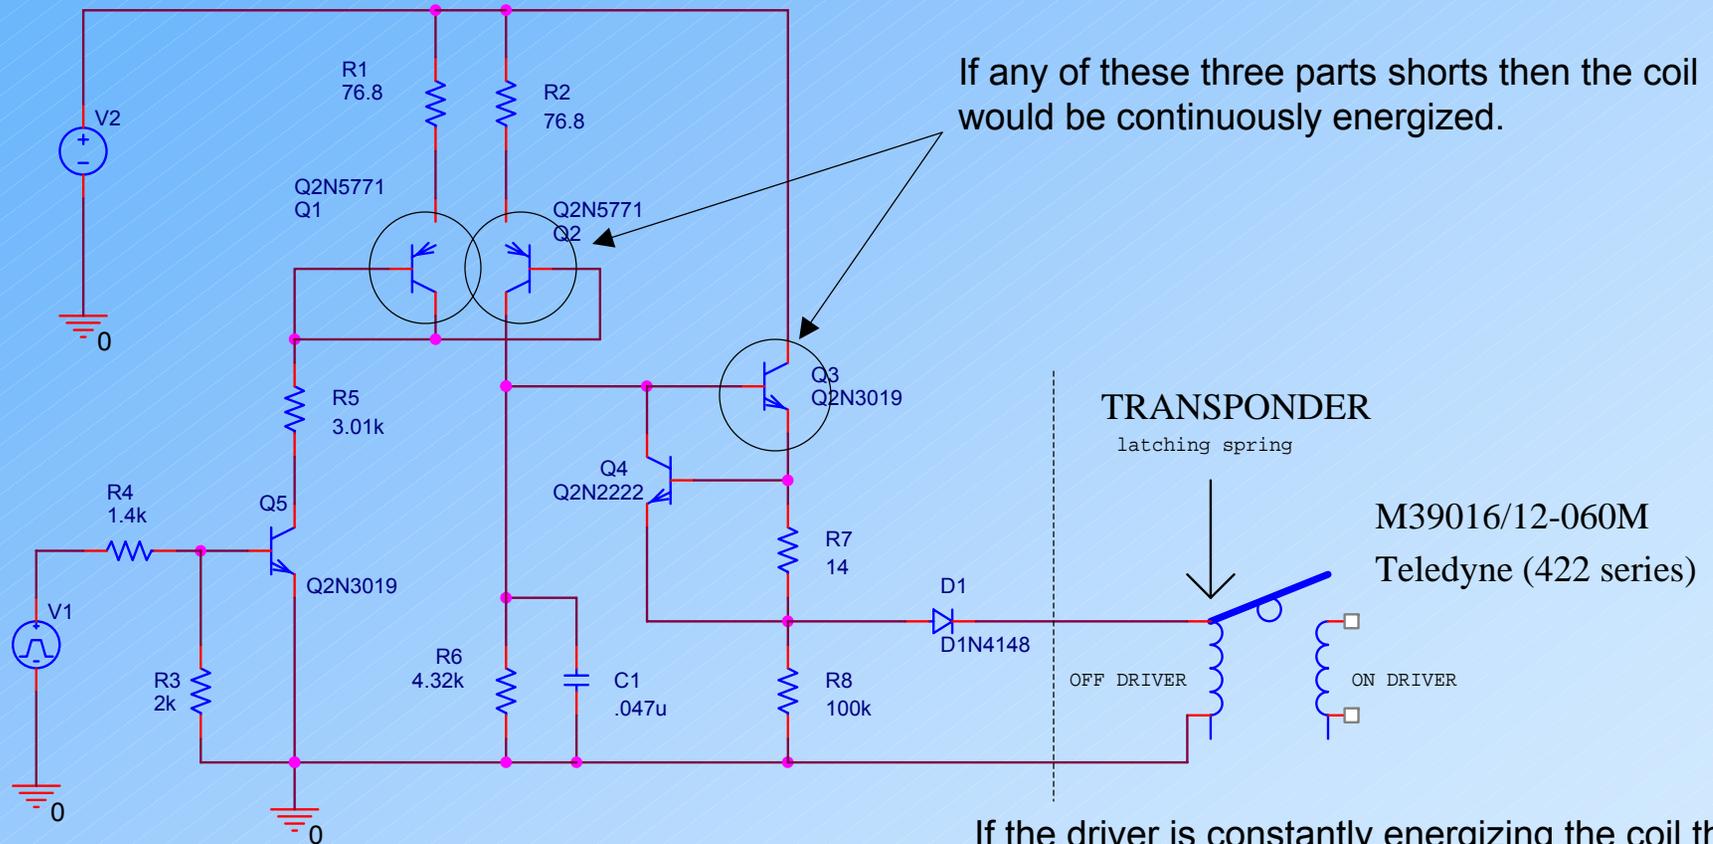
If any of these three parts shorts then the coil would be continuously energized.

If the driver is constantly energizing the coil the magnetic force will keep the relay latched in the open position. Even if the ON driver overcomes the OFF coil field for the pulse duration, the OFF field will latch it back on.

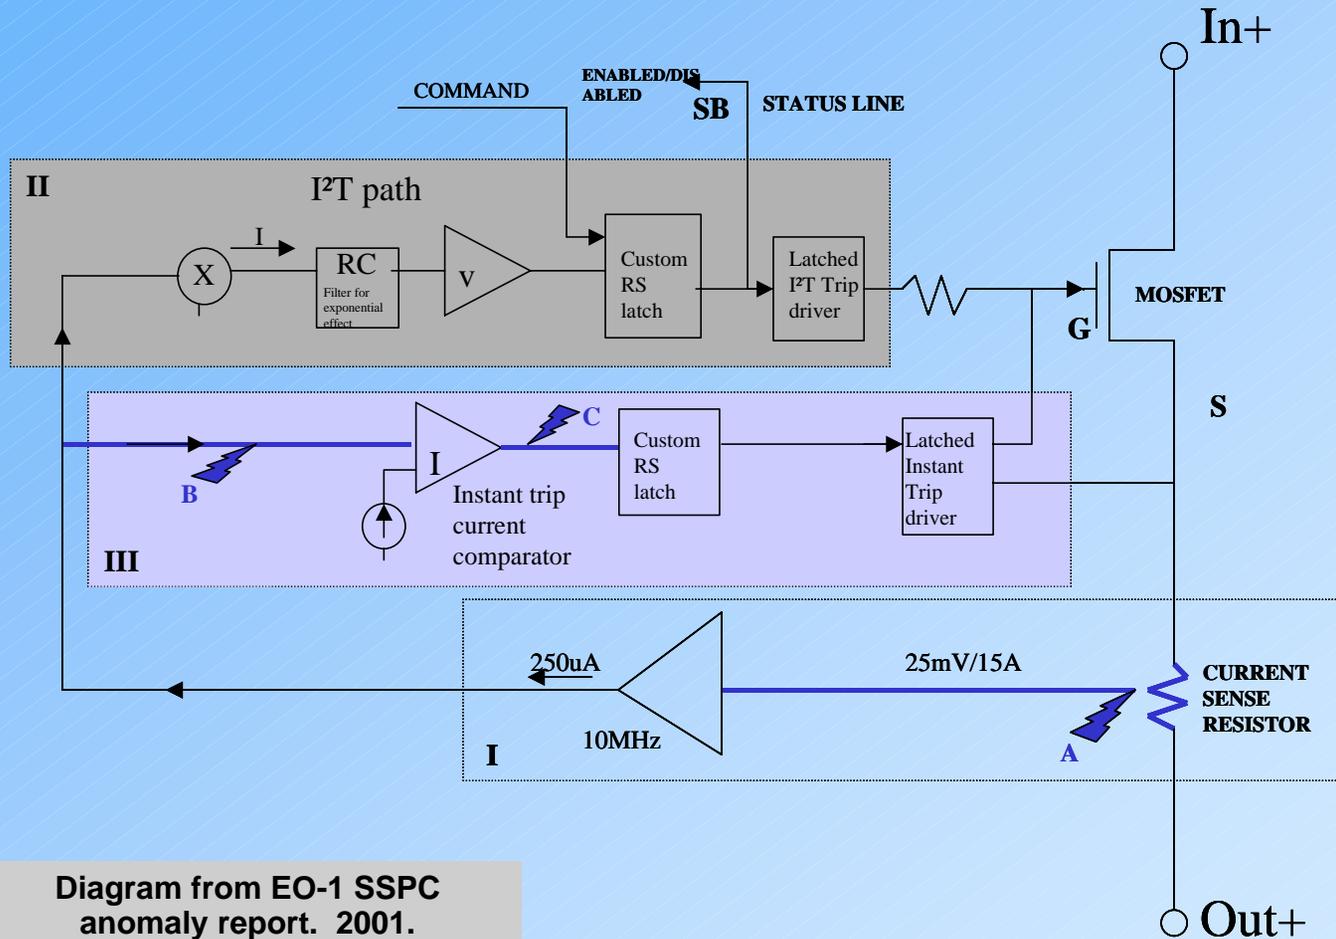
- Previous radiation testing on similar RP-21000 series parts within rated parameters produced mostly temporary drop-out transients of no more than 1 millisecond, which self-recovered. A few persistent dropouts were observed, but it is not known whether these were typical low-level overcurrent trips or Instant Trips. A single event upset specifically in the Instant Trip portion of the circuit could cause a permanent power loss with no signal to the FDC circuits. It should be noted that the tests were run on a different lot of parts, and the test results may not be completely representative of the flight parts.
- SSPC internal block diagram (next page)

= Possible locations for a fast energy particle hit. Any of these will affect the part state without reporting status to the user.

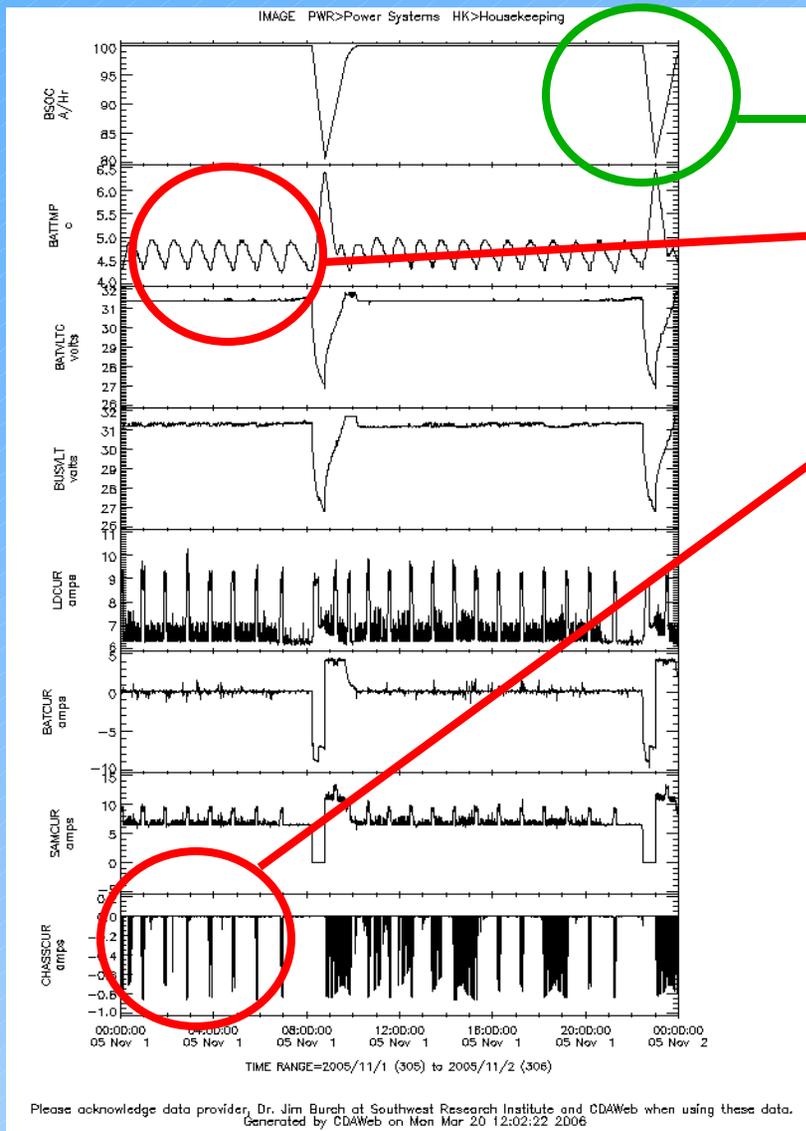
Chassis Current Review (3 of 6) Battery heaters are a Current source

- Large fluctuations of battery SOC due to eclipses.
- Small fluctuations of battery temperature match battery heater activity.
- Chassis current closely correlates to battery heaters.
- Payload heaters were off during this event.

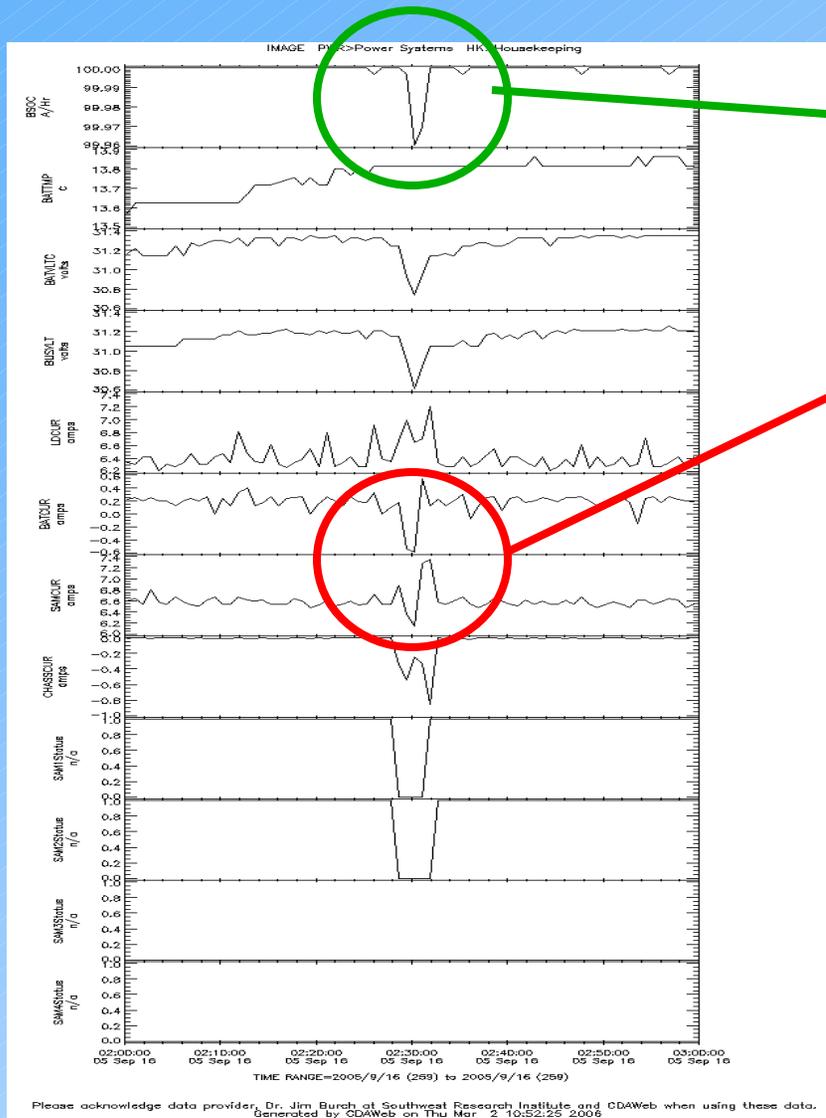
Chassis Current Review (4 of 6) Solar Arrays are Another Source

- This was a brief penumbra-only eclipse.
- Payload deck heaters and battery heaters were off.
- Chassis current occurred when SAMs 1 and 2 opened.

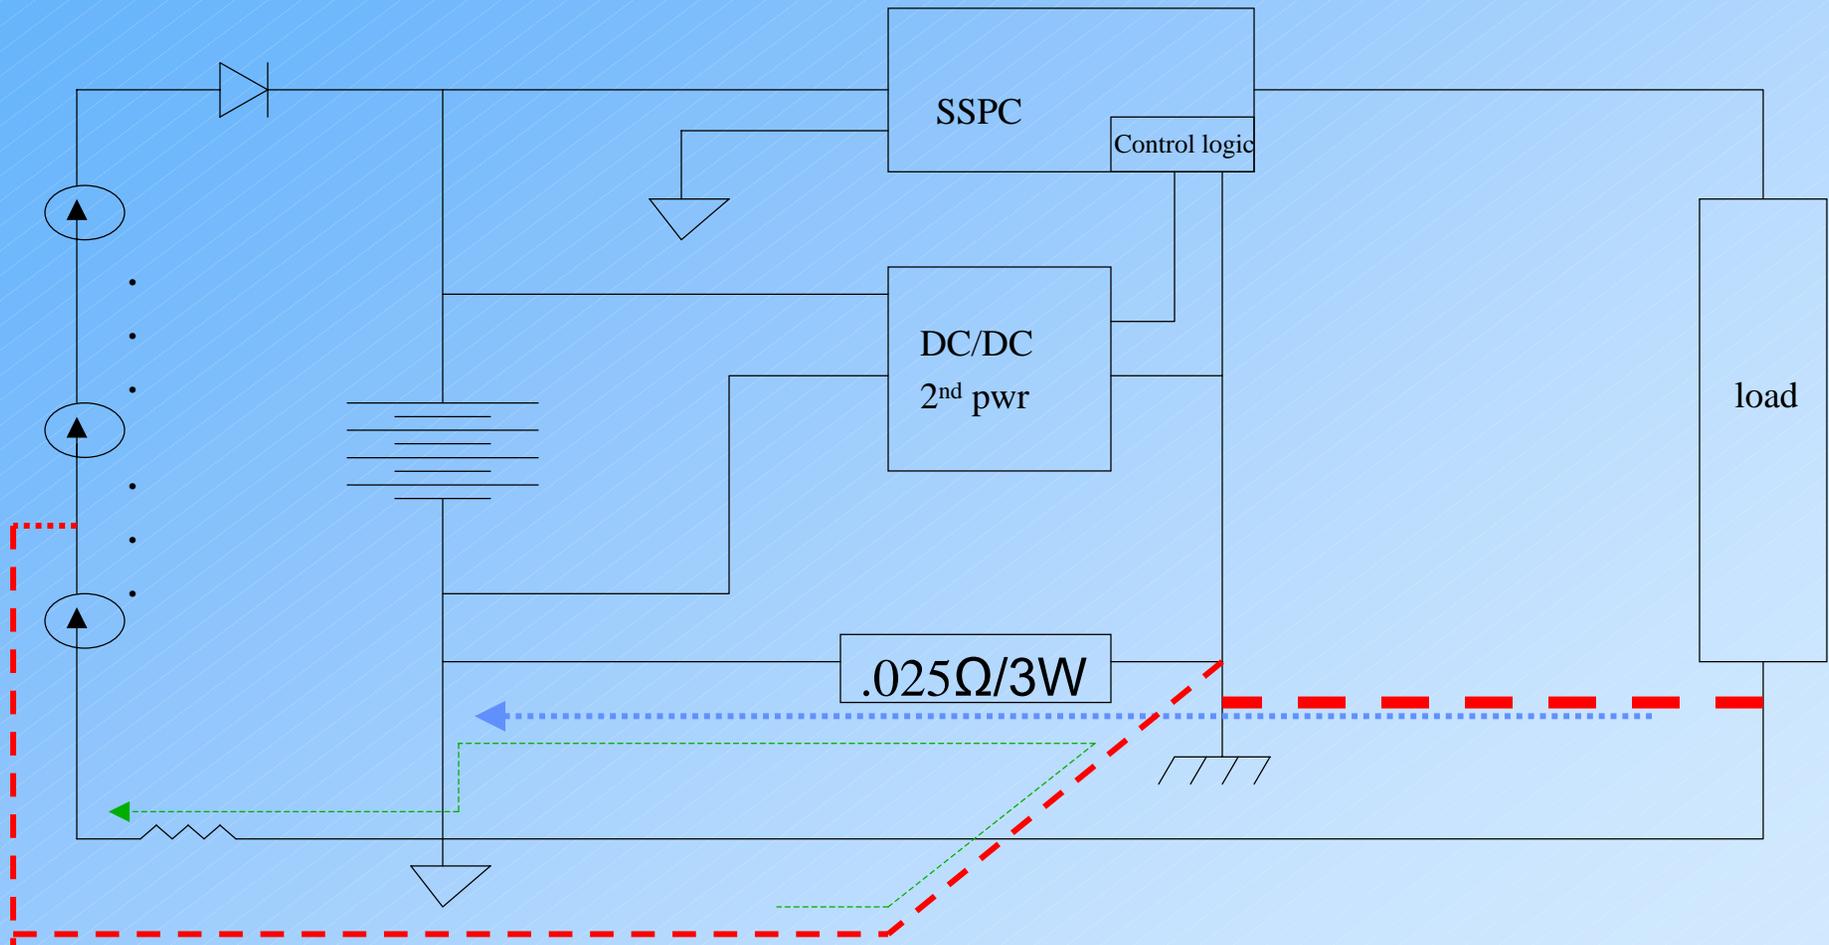
The maximum value of chassis current telemetry is 1A. That accounts for 0.025V of reference shift at the bus return which is not enough to affect a MOSFET gate bias on the SSPC. The chassis current telemetry is negative which means it is flowing from the structure to the bus return. This supports a load return line shorted to chassis.

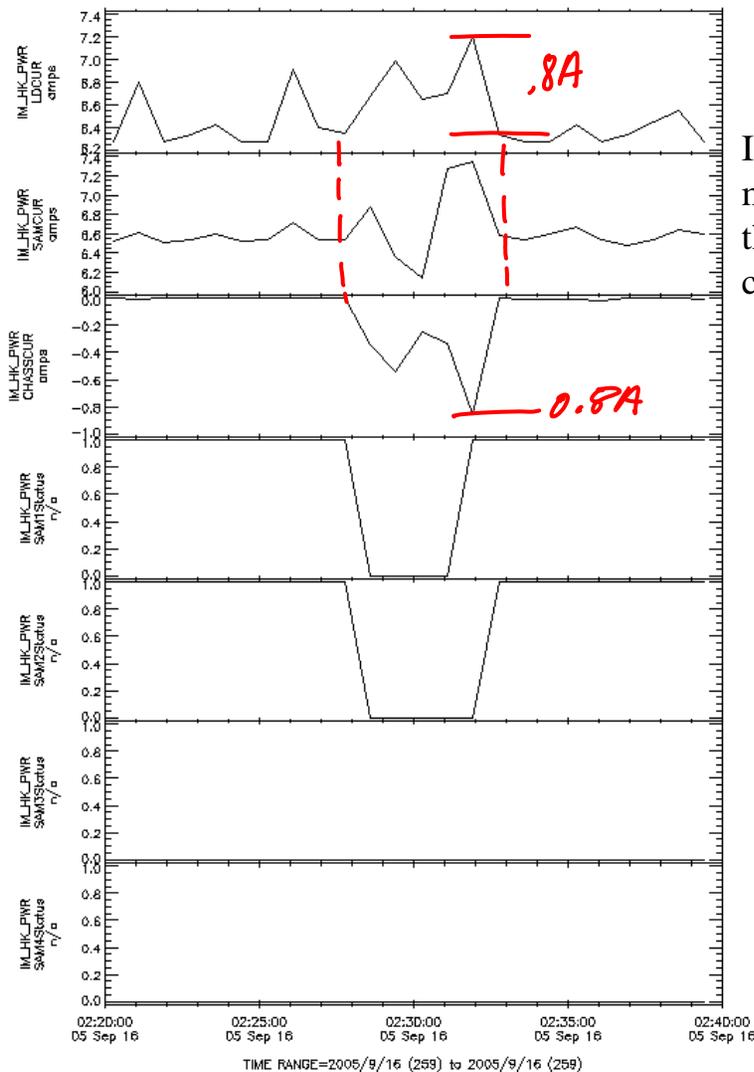
Ichassis mirrors the load current.

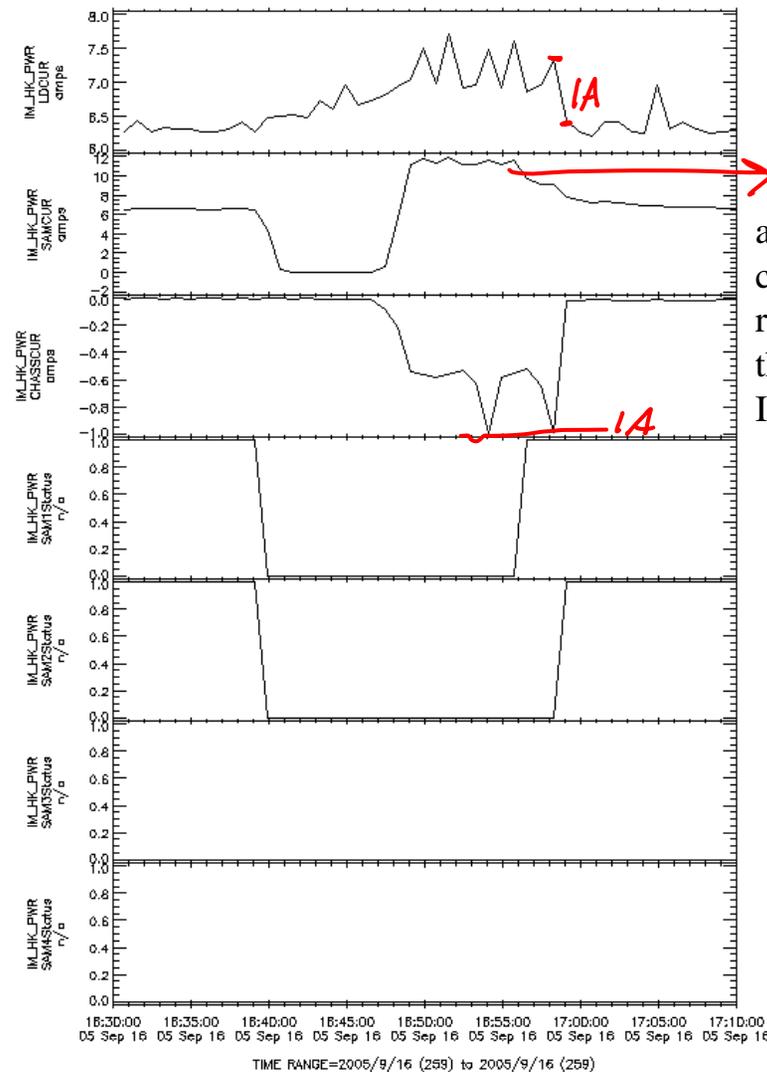
Full array current returns through Isam.

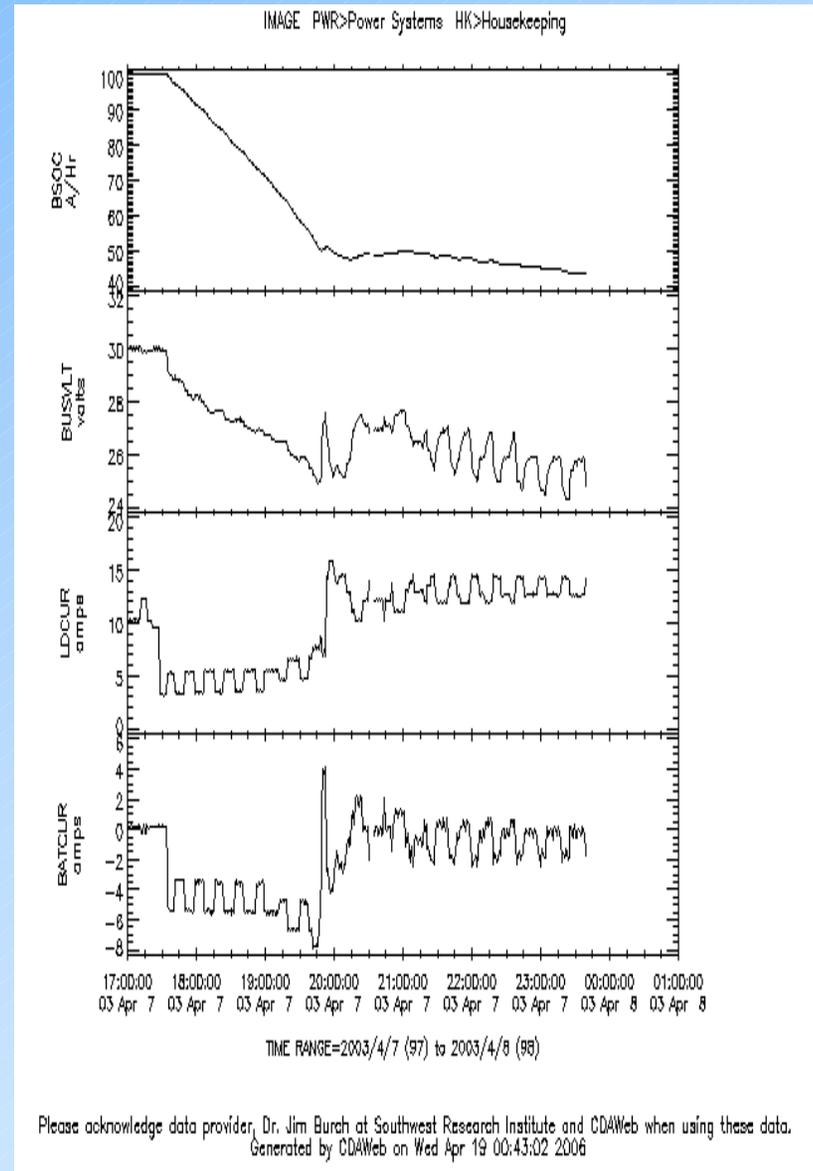
- DSN contact broken at end of data
- SCU reset before Next Contact
- Reset believed due to 24 Vdc Low-Voltage Reset
 - SCU had Rebooted
- 40% SOC alarm probably did ***not*** trigger first
 - Would have removed CIDP and PL heaters from load, allowing bus voltage to recover
 - Would have prevented SCU reset
- Telemetry reporting Alarm trigger counts not fully understood
