IMAGE

Failure Review Board Final Presentation

April 21, 2006

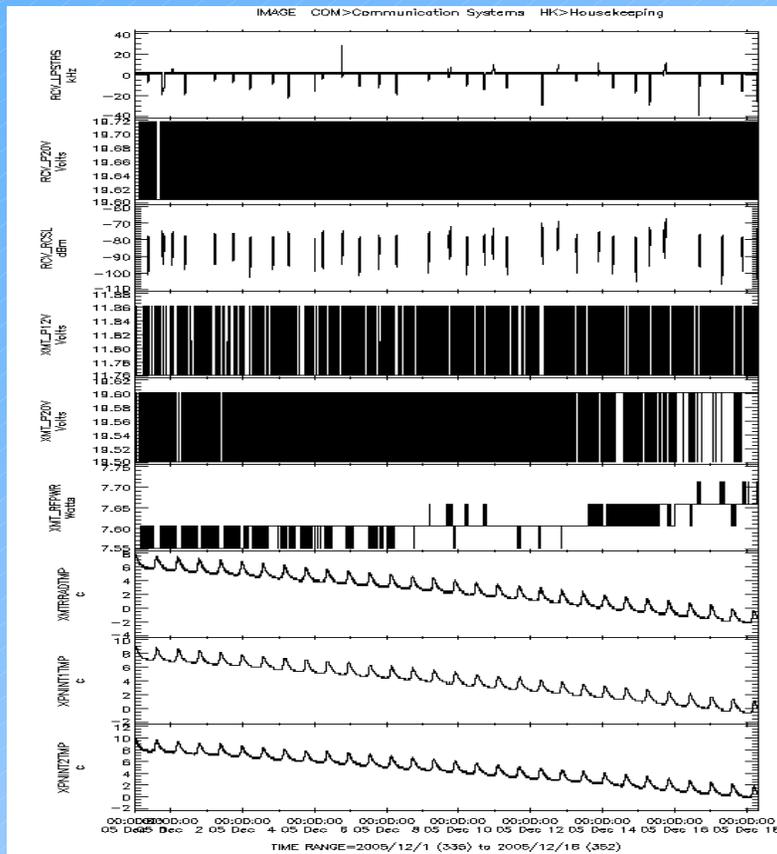
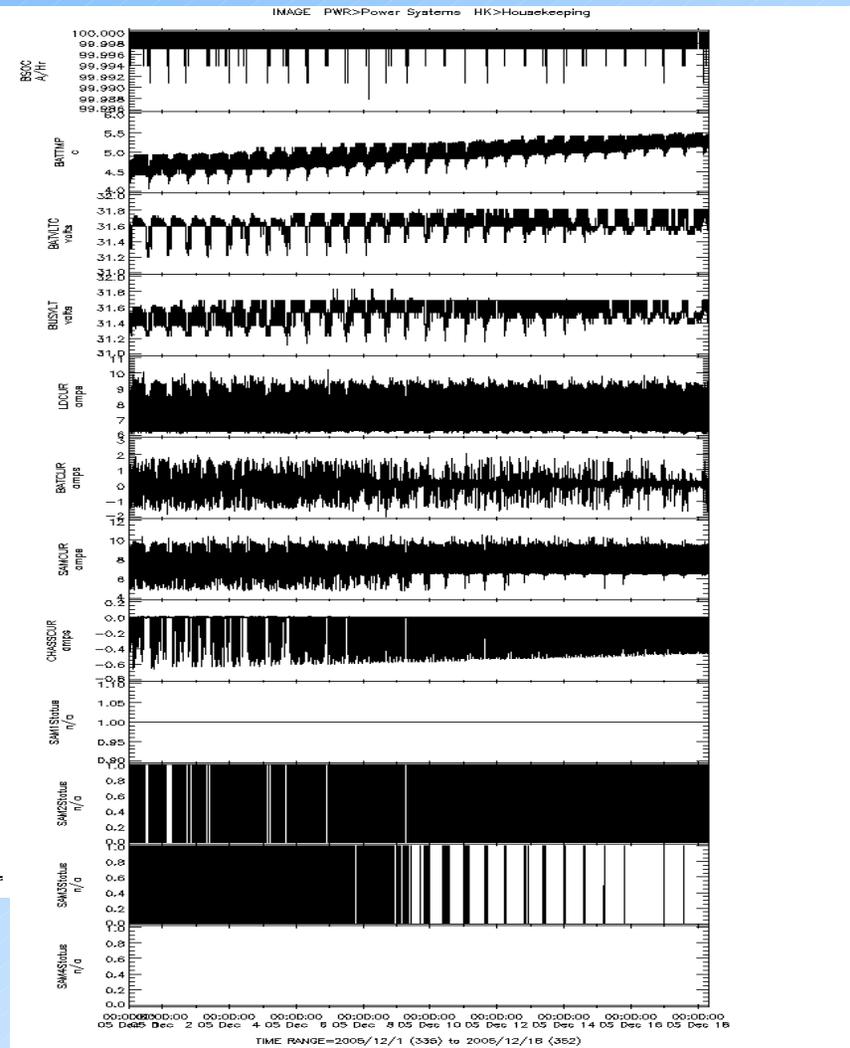
- Trends are inline with previous years.
- All systems nominal during last pass.

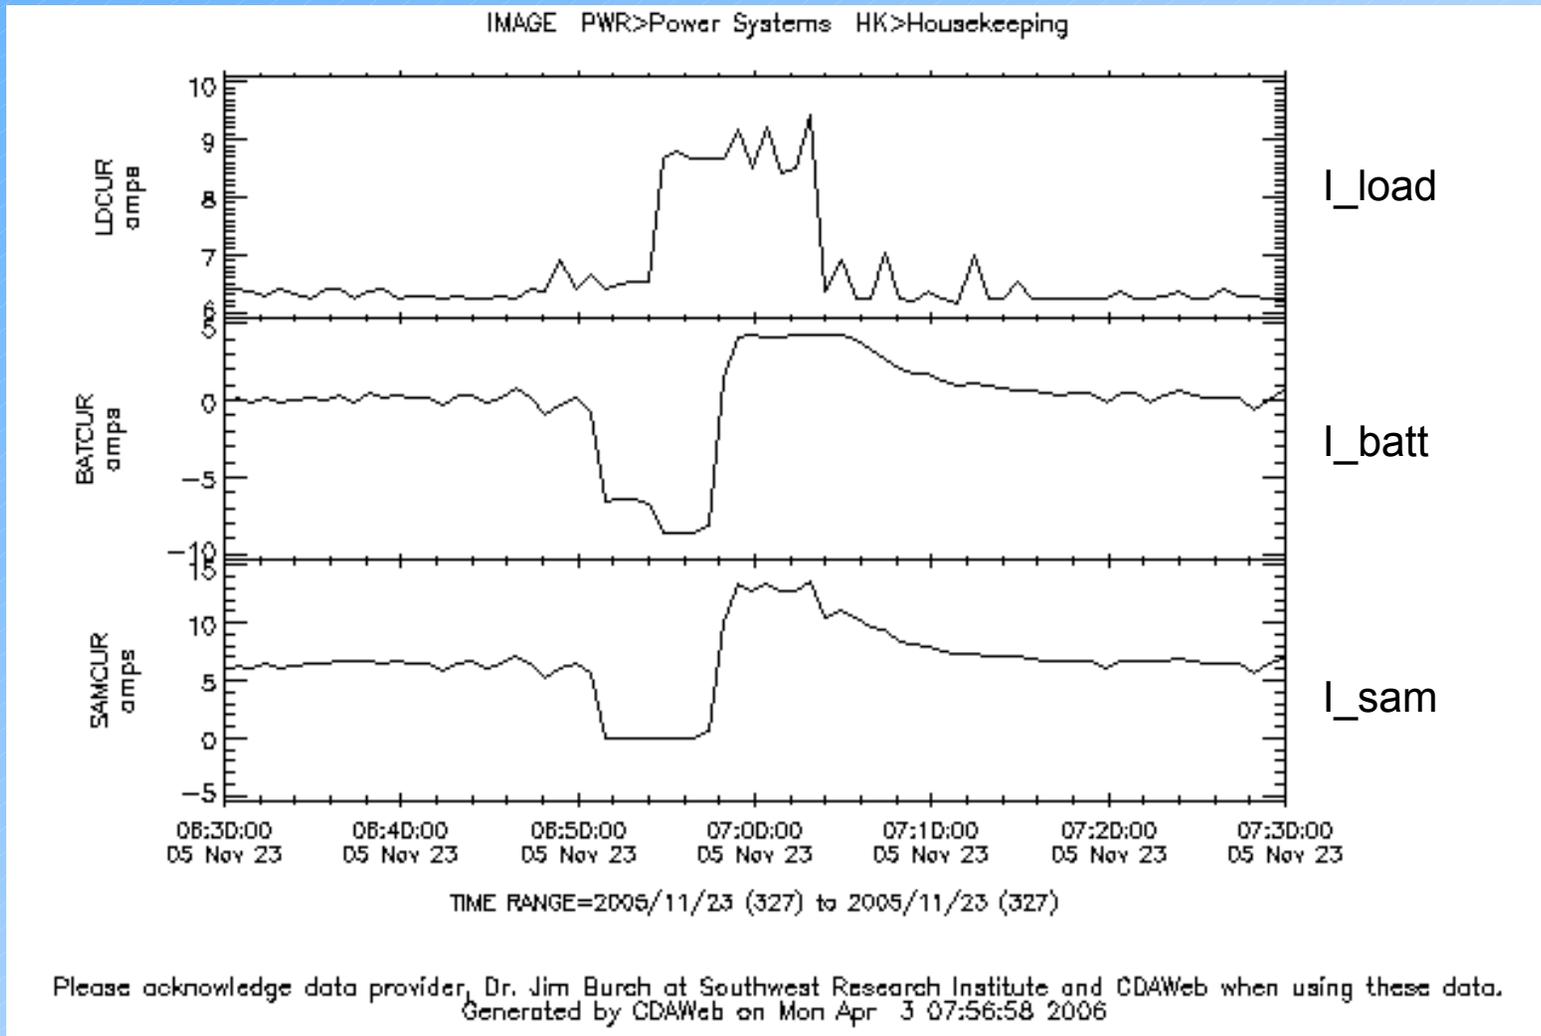
IMAGE Chassis Current Analysis

- Instrument PIs have been queried and have indicated no effect on science.
- ❑ **Given the magnitude, trend, and history of the chassis current, it is highly unlikely that it had any correlation to the anomaly.**

- There is no evidence to suggest the chassis current was progressing toward a catastrophic system short and no evidence that it caused an SSPC instant trip.

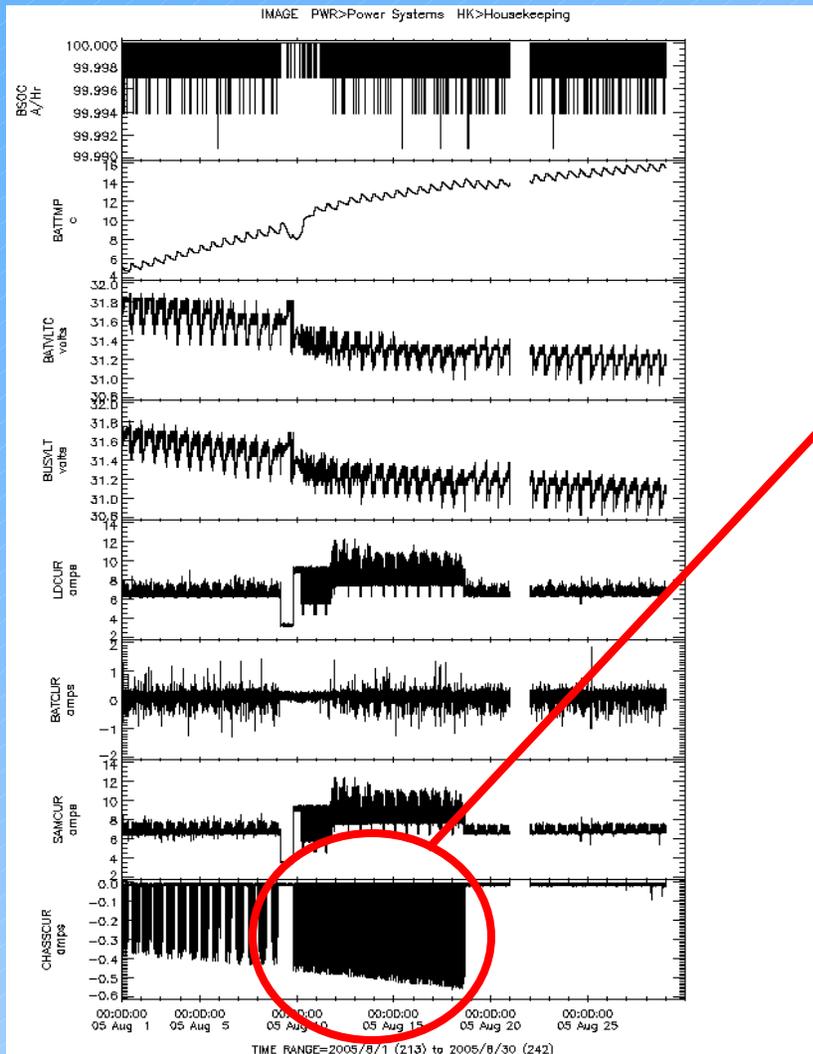
- ❑ Payload anti-sunward during this season. Heater cycling tied to orbit period, and extra heating from albedo.
- ❑ CIDP reboot occurred on 2005/08/09 0411z due to SEU.
- ❑ Chassis Current increased when payload deck heater setpoints increased from their prior level.
- ❑ Chassis Current ceased when setpoints reduced back to minimum on 2005/08/18 1606z.
- ❑ Payload heater activity is clearly one source of chassis current.

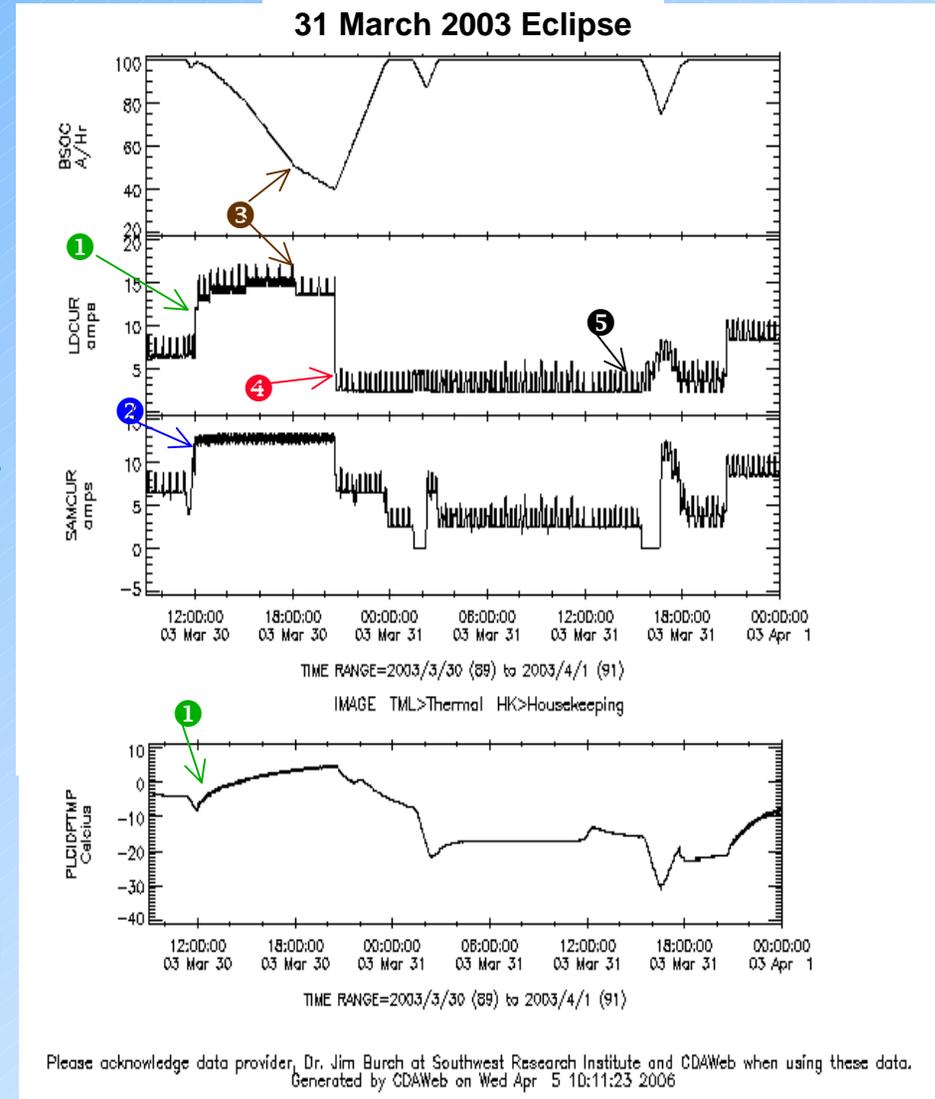
□ Default State after SCU reboot

- SCU startup macro should power on:
 - Payload Survival (Thermostatic) Heaters
 - Transmitter (presumed not powered due to SSPC fault)
 - Battery Heaters
 - Sun Sensor Heater
 - AST and Sun Sensor
- Historic model is 31-Mar-2003
 - Previous Power-down due to 40% SOC macro activation
 - Transmitter was on, rather than off
 - Otherwise similar Solar geometry and power condition to Oct 2007
- Current Draw Averages 5.25 Amps
 - Duty cycled due to heaters
 - Includes Transponder Power

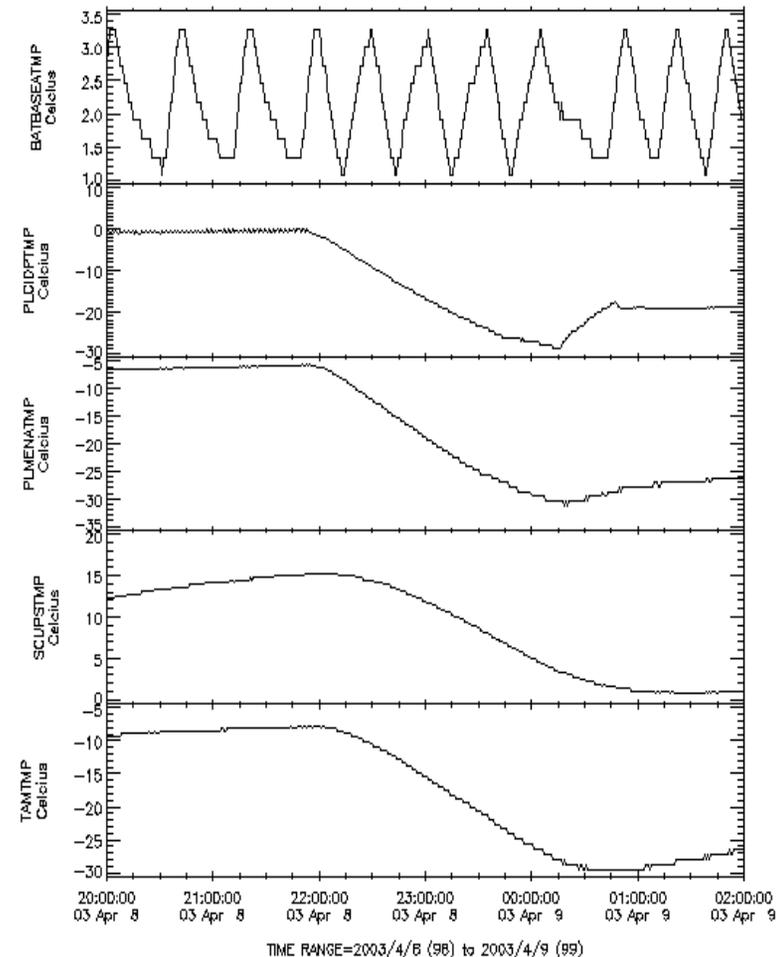
- ❑ Temperatures Decline to Survival Limits
- ❑ Decline Rates Based on Rates of 08-Apr-2003
 - Battery (cycling due to heater)
 - CIDP and MENA/FUV
 - Note CIDP was powered Here
 - SCU Power Supply
 - Magnetometer
- ❑ At Survival Limits, Thermostatic Survival Heaters kick on
- ❑ Lapse Rate for all PL elements is between 10 and 15 C per hour in eclipse
- ❑ Survival Temperatures Reached in One Hour (+/- 10 minutes estimated)

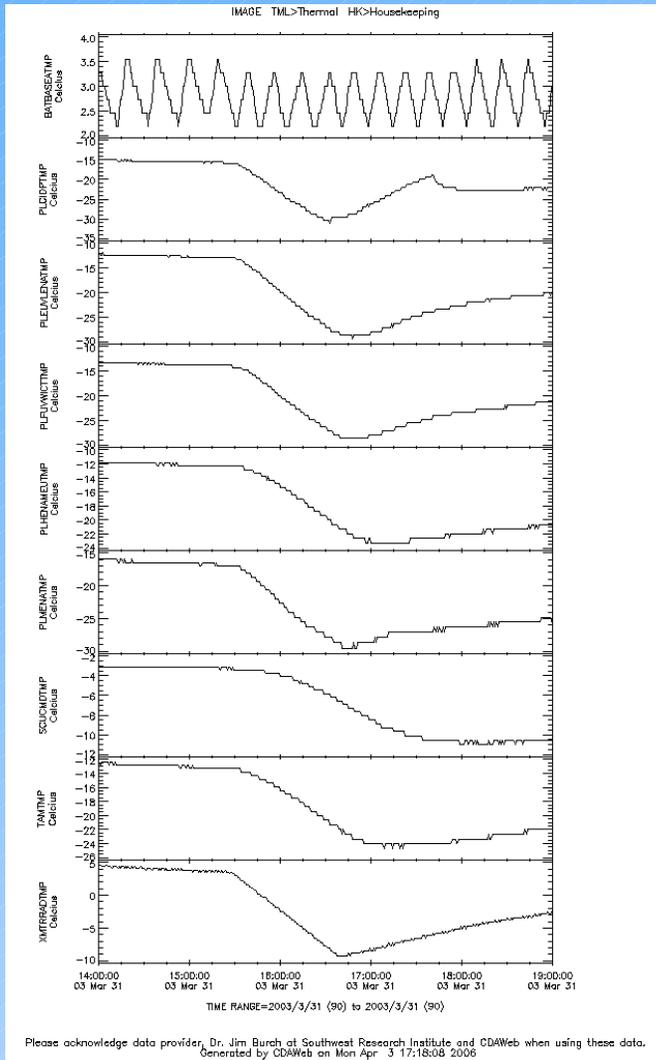
- ❑ Full Thermal Response for 31-Mar-2003 Eclipse
 - Payload Elements Track CIDP temperature closely

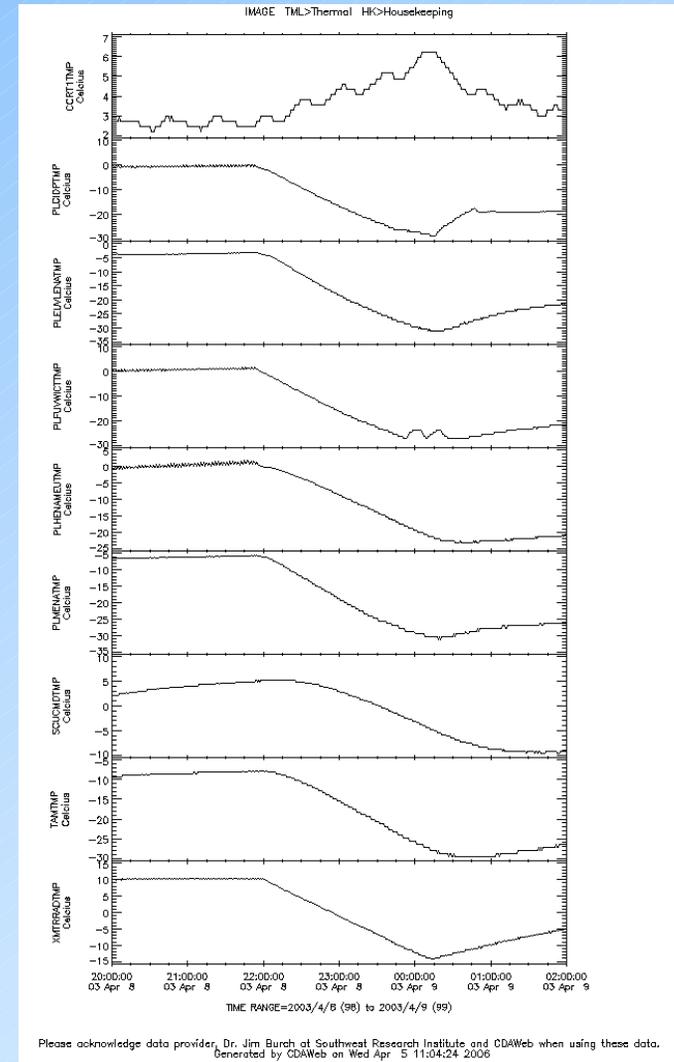
- ❑ Complete Thermal Cool-Down Response During 08-Apr-2003 Eclipse
 - Payload Temperatures All Track at Similar Rates
 - Battery warms during high-rate discharge, cools slowly thereafter

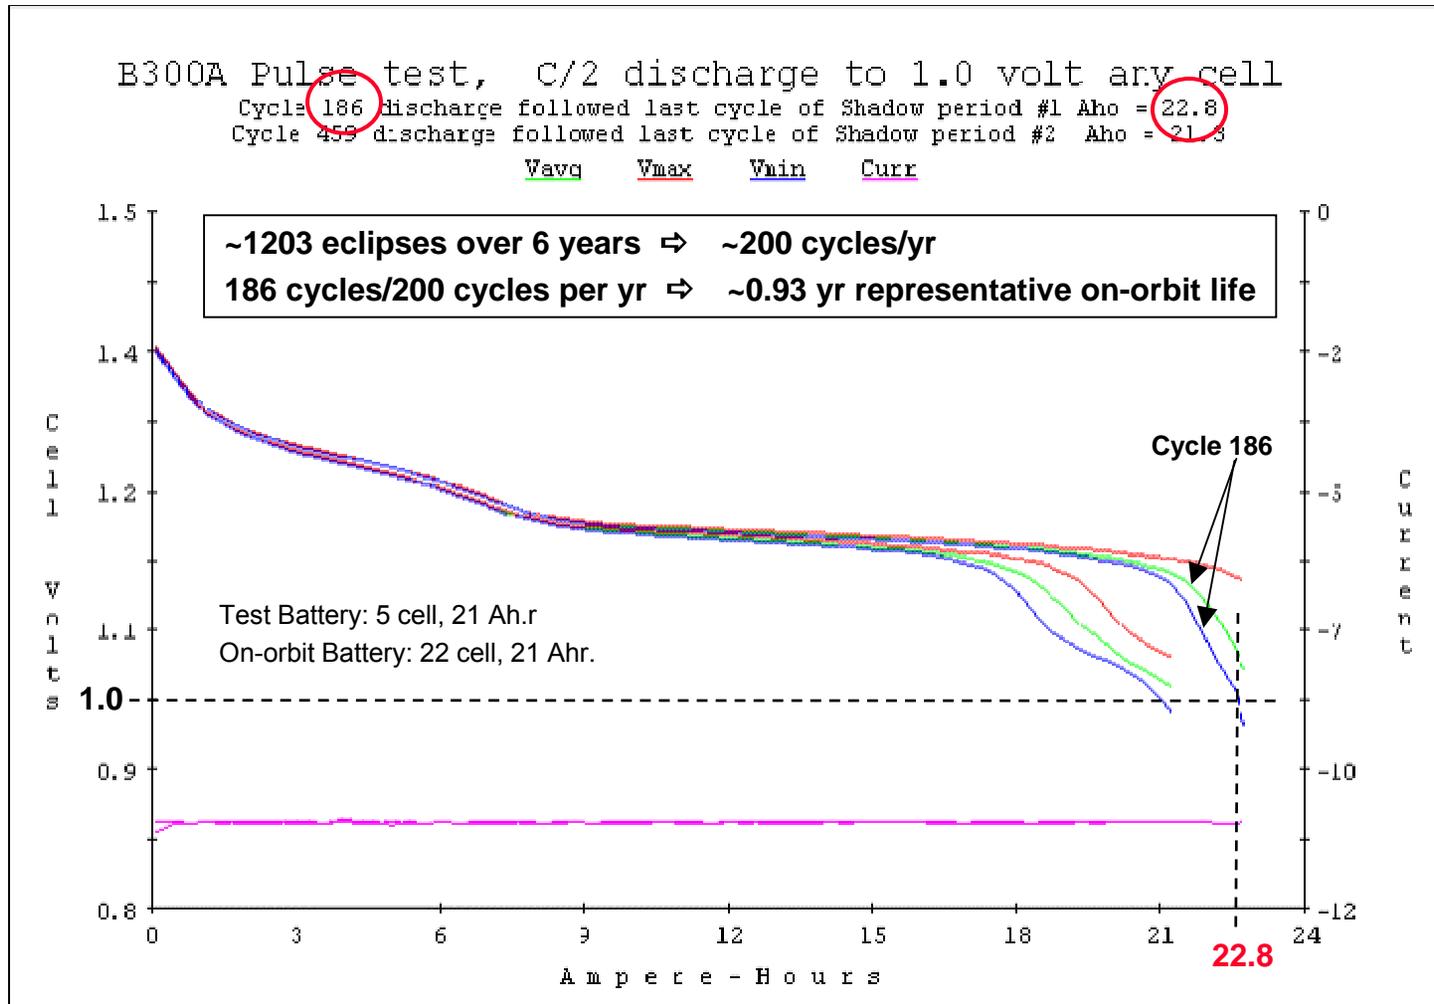
- ❑ Battery capacity degradation rate is estimated at 1.62 Ahr/yr.
 - Representative on-orbit life between cycle 186 and 520 is 1.67 years
 - **2.6 yr (cycle 520) – 0.93 yr (cycle 186) = 1.67 yr.**

- Capacity degradation between cycle 186 and 520 is 2.7 Ahr.
 - **22.8 Ahr (cycle 186) – 20.8 (cycle 520) = 2.7 Ahr.**
 - Rate of capacity degradation is 1.62 Ahr/yr.

- **2.7 Ahr/1.67 yr = 1.62 Ahr/yr.**
 - ‘Worst case’ estimate because capacity is represented by weakest cell.
 - Assume linear degradation rate.
 - Rate likely increases with age giving a actual lower capacity than assumed.
